Mr. H. Haynes  
3 Trevelgue Road  
Newquay  
TR7 3LY

6<sup>th</sup> August 2024

**INSPECTION OF BUILDING WORK CARRIED OUT - GAMES ROOM AT 3 TREVELGUE ROAD**

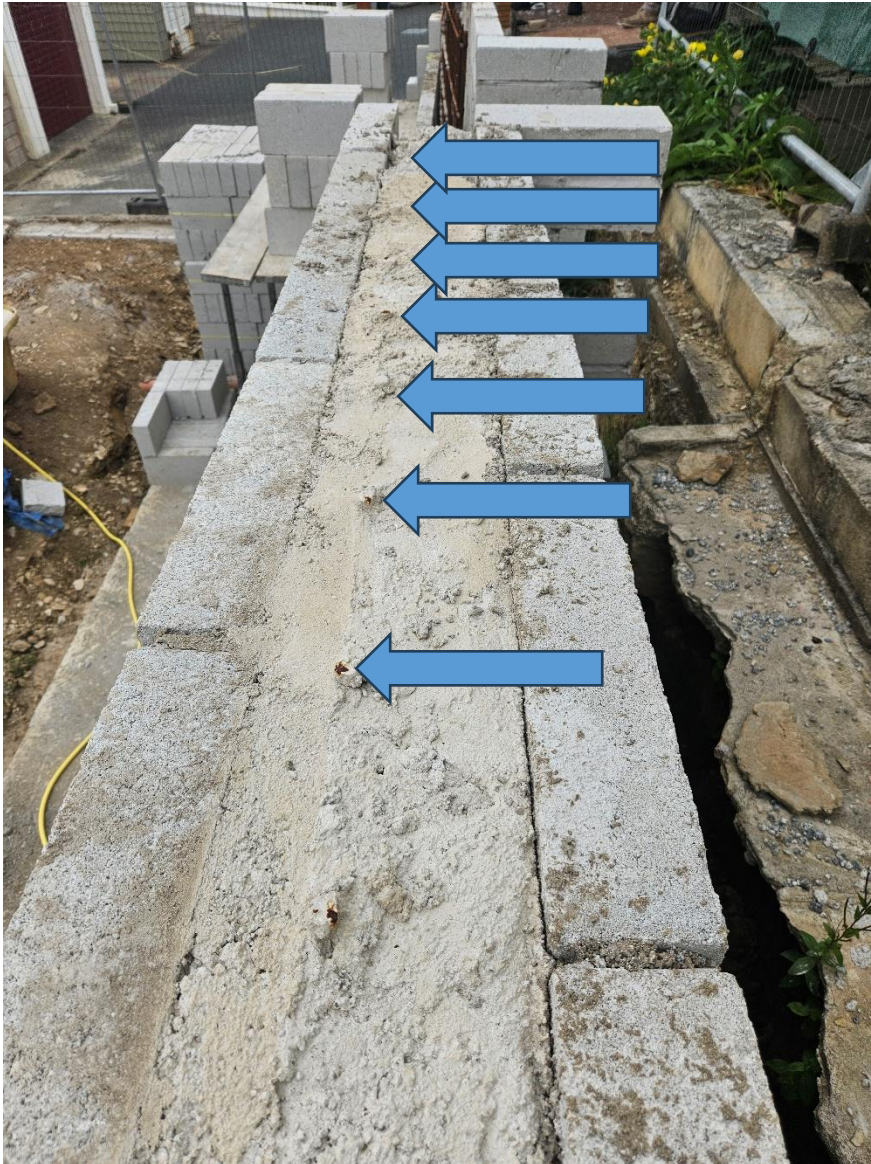
The reinforcement in the North wall of the games room has been positioned correctly in the base, and subsequently in the correct position within the cavity, however when the concrete was poured the reinforcement has been allowed to move forwards, and in two locations is against the face of the inner leaf of masonry. This will mean that the reinforcement is essentially ineffective in these areas. The blue arrows in photograph 1 below show the position of the reinforcement in wall where concrete has been poured full height. Photograph 2 shows the reinforcement in the section of retaining wall that has been partially filled with concrete; it can clearly be seen how the reinforcement has been allowed to move within the cavity. To rectify this issue, the concrete will need to be broken away, and the reinforcement re-set in the correct position. The concrete will then need to be repoured, and adequately vibrated to ensure no voids or air bubbles exist.

*Photo 1 - Rear retaining wall, reinforcement in incorrect position*

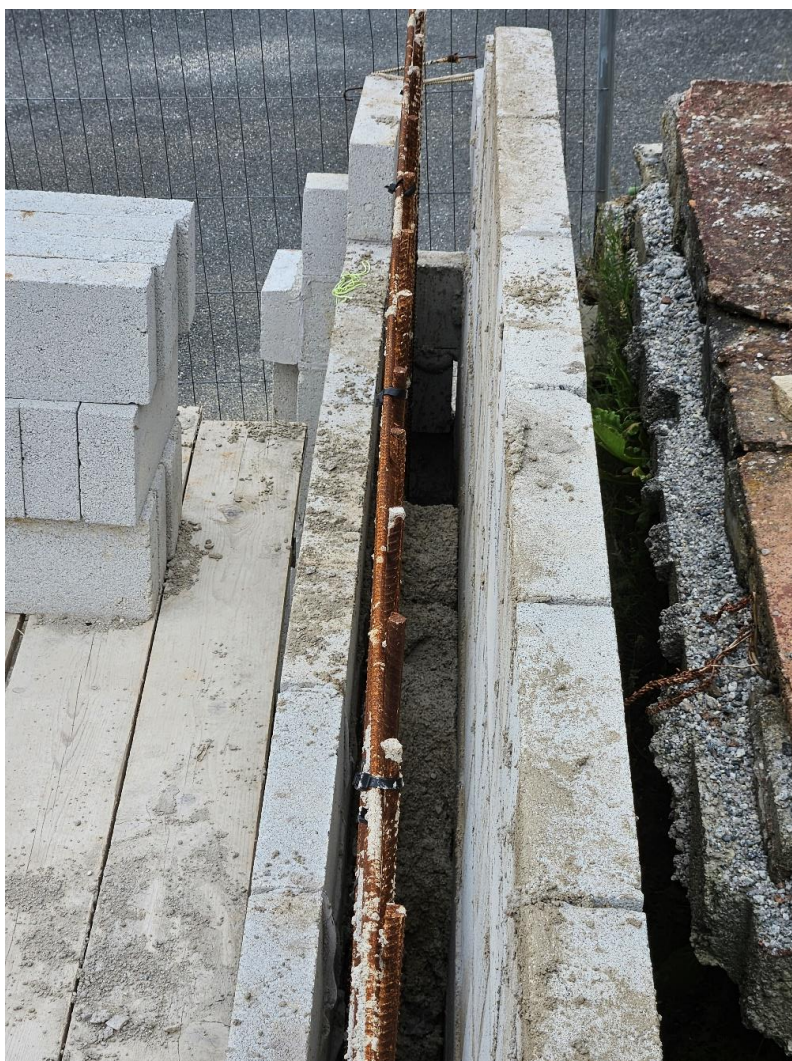
*Photo 2 - Rear retaining wall, reinforcement in incorrect position*

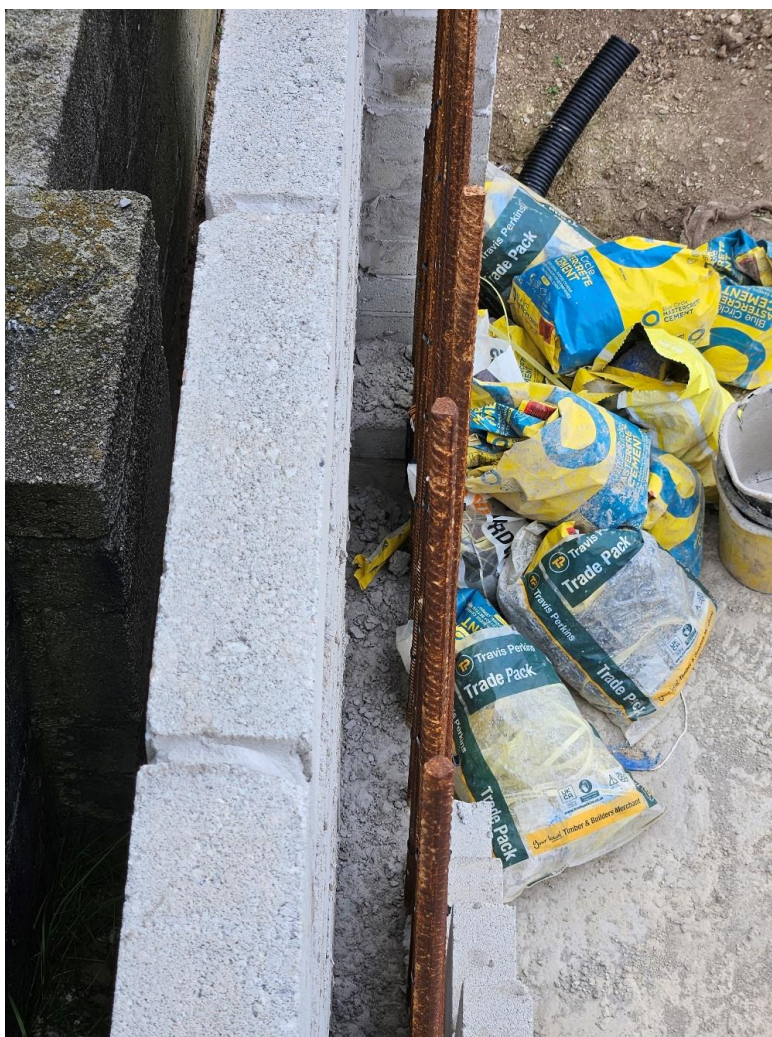
The reinforcement in the side retaining wall is also not in the correct position, however in this instance the starter bars in the base have been placed incorrectly, resulting in the reinforcement coming out of the base immediately against the inner face of the inner block leaf, as can be seen in photograph 3. Rectification of this issue is more intensive than that in the rear retaining wall, as the base reinforcement has been placed in the wrong position, rather than the reinforcement having moved due to concrete pressure. Fortunately, however, this wall is not actually retaining soil as it is set approximately 300mm from the boundary wall, with a void between. This wall may therefore be still filled with concrete, however the position of the reinforcement is irrelevant as it will never be required to provide bending strength to the wall.

*Photo 3 - Side retaining wall, starter bars not in correct position*
